NATIONAL ENGINEERED LIGHTWEIGHT  
CONSTRUCTION FIRE RESEARCH PROJECT

TECHNICAL REPORT:  
LITERATURE SEARCH  
&  
TECHNICAL ANALYSIS

Kirk Grundahl, P.E.

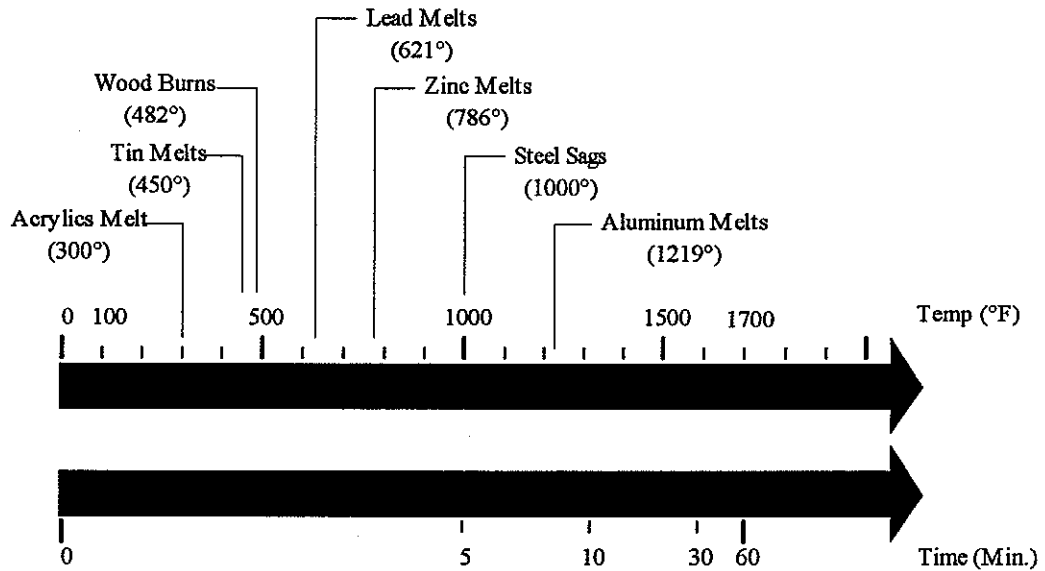
A figure that shows the severity of the ASTM E119 time/temperature in terms of material properties has been prepared and is shown in Figure 28.

Figure 28. ASTM E119 Standard Fire Exposure <sup>4</sup>
